Participatory Identification of Major Natural Resource Constraints and Potentials Under Koka-Lewate Watershed, Tembaro Woreda, Kambata Tambaro Zone of Southern Ethiopia

Natural Resource Management Directorate, Southern Agricultural Research Institute, Areka Agricultural Research Center, Areka, Ethiopia

Abstract: Koka-Lewate watershed is located in the Tambaro district of Southern Ethiopia and it is about 328 km and 185 km far from Addis Ababa and Hawassa respectively. It was selected by a virtual team (team of researchers from a natural resource, crop science, livestock, and socioeconomic departments) organized from Areka Agricultural Research Center, Southern Agricultural Research Institute (SARI). It was selected for its high level of degradation, minimal intervention and high amount of sediment load contribution on the Gibe III hydroelectric power dam. This study aimed to identify and prioritize natural resource constraints of the watershed and to document reports as baseline information for comparison after project implementation. Data for this study were collected from primary and secondary sources. The study catchment is characterized by intensive. The study revealed, soil

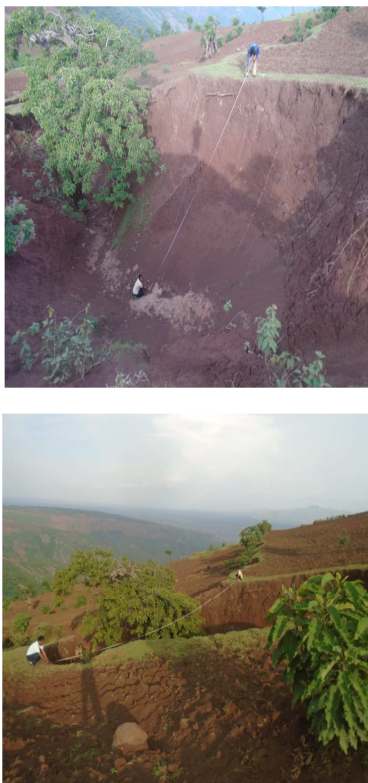
Figure 3. Soil erosion and land degradation under Koka-Lewate watershed (Source; field survey, 2017).

Soil erosion is a significant environmental problem affecting agricultural productivity of study catchment. Discussion held with farmers and extension agents revealed that due to undulated topography, cultivation of steep slope and marginal lands, intensive rainfall with erratic nature, free grazing, and deforestation; soil erosion frequently occurs in the watershed. From field observation, researchers perceived that sheet and rill erosion which are caused by intensive rainfall coupled with cultivation of sloppy and marginal lands are dominant types of soil erosion in the area. In some parts of the catchment, deeper and wider gullies were also observed. Farmers were well acquainted with the negative impact of soil erosion on their lives. They pointed out that, the level of erosion is severe and caused several hazardous. Among these, damage to the house, damage to crops and fertilizers, road break, farmland fragmentation, drought and drying of spring are common ones. Damage on animals and humans by flood during a heavy rainstorm is also reported. Severe downstream siltation and deposition were identified as soil erosion problems in the study area. Shortly, this may pose a harsh impact on Gibe III hydroelectric power dam [13]. Although soil erosion has a severing effect, the use of physical conservation measures are not carried out by farmers' initiative but initiated by government organizations. As a result, constructed conservation structures failed to serve the planned reason. Besides, inappropriate design, wrong structure selection, and construction, damage by heavy runoff, human activities and animal (grazing), lack of follow-up and maintenance are observed problems under study catchment. As cited by respondents, currently the soil needs extra inputs and labor to provide them satisfactory products because of fertility degradation caused by soil erosion. Respondents also reported workable soil depth is decreasing year to year.

The finding depicts that, indicators of soil erosion perceived by farmers were formation of rills and gully, poor in crop and grass growth, change in soil color, roots and subsoil exposure, difficult of land preparation, and sediment deposition at depressions 97.9%, 83%, 72.3%, 63.8%, 44.7%, and 34% respectively. Almost all respondents were aware of soil erosion impact on the food security of their household.

Farmers manage soil erosion problems using both physical and biological conservation measures. Tree plantation, plantation of banana and desho grass, contour plowing, soil bund, stone bund, fanya juu terrace, and cutoff drain are common in the area. Experts revealed that the use of biological conservation measures is very limited in type and area coverage. In general, lack of adequate and effective soil and water conservation measures coupled with poor management of the existing conservation measures have led the problem of soil erosion to continue.
